**Flood Control Project Maintenance
Levee Inspections**
LMA District Cover Sheet
Spring 2019 Levee Inspection Results

American River Flood Control District

Spring 2019 Levee Inspection Results

Waterway			Bank	Unit Miles
Unit No. 01 Arcade Creek			Left	2.08
	Spring (March - May)	Summer (June - August)	(September - November) Fall	Winter (December - February)
Unit Maintenance Rating (Fall Only)				
Date of Inspection	5/14/2019 - 5/14/2019			
DWR Inspector	Luz Dial			
Accompanied By	Ross Kawamura ARFCD

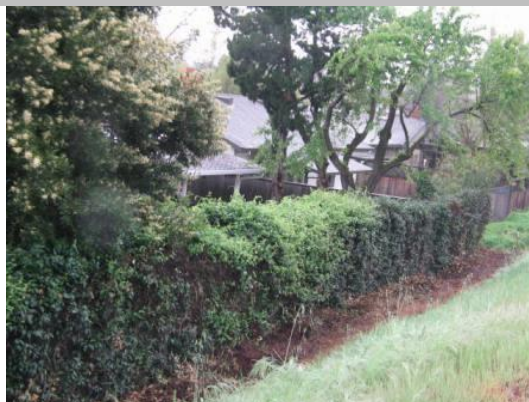
Photo 1 of 1 : SP_2019_NA0001_55_107_20190307_00095.jpg

LM Start	8.47	Rating **	U	Issue No.	107
LM End	8.47	Issue Type +	En	Location *	LS
Category	Earthen Levee			GPS Latitude/Longitude	
				Start	End
Item	Vegetation			38.563511 °	38.563511 °
				-121.389509 °	-121.389509 °
DWR ID	DWR_NA0001_04_s_2012_107				
Comment Code					
V6 : Landscaping					
Inspector Comment

03/16/2012 Landscaping obstructs visibility and access.

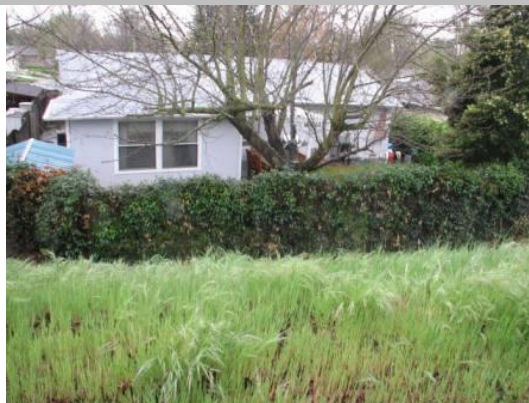
Photo 1 of 1 : SP_2019_NA0001_55_108_20190515_00269.jpg

LM Start	8.48	Rating **	U	Issue No.	108
LM End	8.48	Issue Type +	En	Location *	LS
Category	Earthen Levee			GPS Latitude/Longitude	
				Start	End
Item	Vegetation			38.563482 °	38.563482 °
				-121.389368 °	-121.389368 °
DWR ID	DWR_NA0001_04_s_2019_108				
Comment Code					
V6 : Landscaping					
Inspector Comment					
Chainlink fence and landscaping block visibility and access.

03/16/2012 Landscaping obstructs visibility and access.

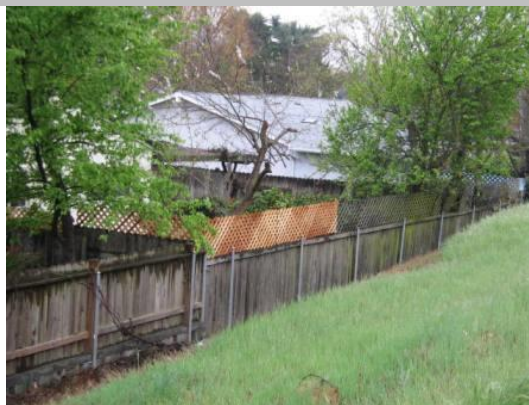
Photo 1 of 1 : SP_2019_NA0001_55_109_20190307_00097.jpg

LM Start	8.49	Rating **	U	Issue No.	109
LM End	8.49	Issue Type +	En	Location *	LS
Category	Earthen Levee			GPS Latitude/Longitude	
				Start	End
Item	Encroachments			38.563580 °	38.563580 °
				-121.389140 °	-121.389140 °
DWR ID	DWR_NA0001_04_s_2012_109				
Comment Code					
FE : Fence					
Inspector Comment					
Wood privacy fence within 10-ft of levee toe obstructs access and visibility.

03/16/2012 Wood privacy fence completely obstructs access and visibility.

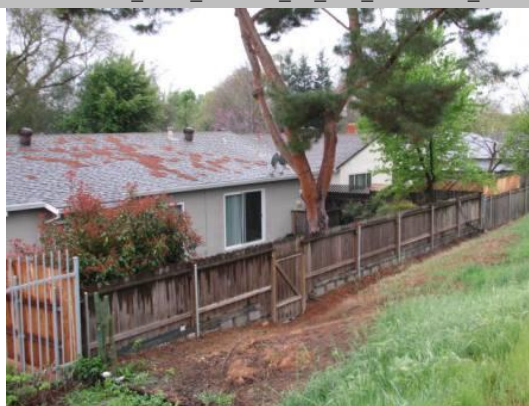
Photo 1 of 1 : SP_2019_NA0001_55_110_20190307_00098.jpg

LM Start	8.51	Rating **	U	Issue No.	110
LM End	8.51	Issue Type +	En	Location *	LS
Category	Earthen Levee			GPS Latitude/Longitude	
				Start	End
Item	Encroachments			38.563732 °	38.563732 °
				-121.388930 °	-121.388930 °
DWR ID	DWR_NA0001_04_s_2012_110				
Comment Code					
FE : Fence					
Inspector Comment					
Wood privacy fence within 10-ft of levee toe obstructs visibility.

03/16/2012 Wood privacy fence completely obstructs access and visibility.

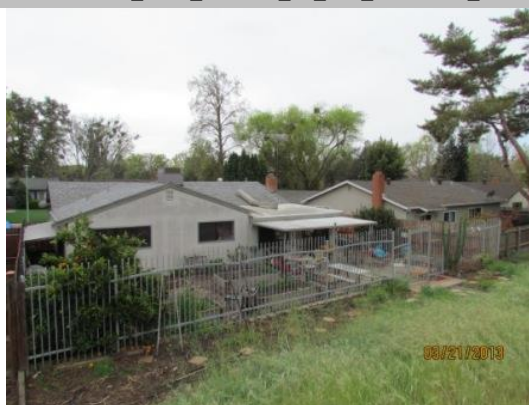
Photo 1 of 1 : SP_2019_NA0001_55_226_20190307_00185.jpg

LM Start	8.52	Rating **	M	Issue No.	226
LM End	8.52	Issue Type +	En	Location *	LS
Category	Earthen Levee			GPS Latitude/Longitude	
				Start	End
Item	Vegetation			38.563793 °	38.563793 °
				-121.388758 °	-121.388758 °
DWR ID	DWR_NA0001_04_s_2012_226				
Comment Code					
V6 : Landscaping					
Inspector Comment					
Garden, trees, and cactus are planted within the levee toe easement.

View of landscaping at the levee toe.

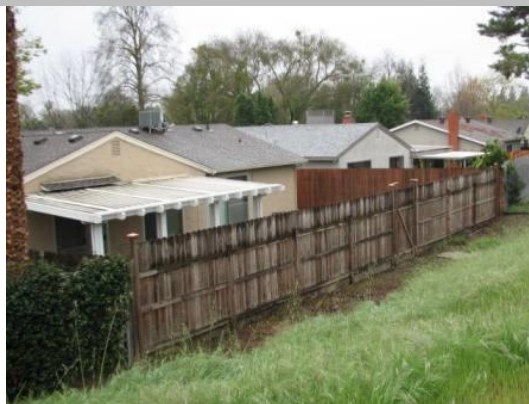
Photo 1 of 1 : SP_2019_NA0001_55_111_20190307_00099.jpg

LM Start	8.53	Rating **	U	Issue No.	111
LM End	8.53	Issue Type +	En	Location *	LS
Category	Earthen Levee			GPS Latitude/Longitude	
				Start	End
Item	Encroachments			38.563820 °	38.563820 °
				-121.388518 °	-121.388518 °
DWR ID	DWR_NA0001_04_s_2012_111				
Comment Code					
FE : Fence					
Inspector Comment					
Wood privacy fence within 10-ft of levee toe obstructs access and visibility.

03/16/2012 Wood privacy fence completely obstructs access and visibility.

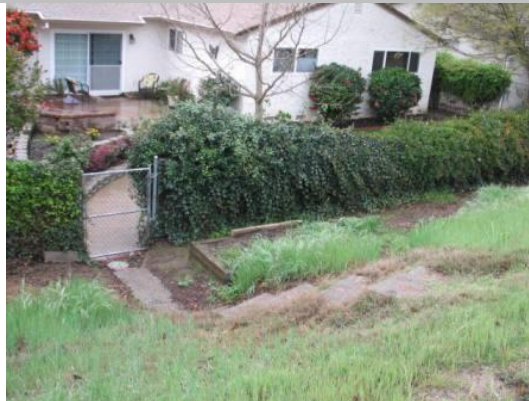
Photo 1 of 1 : SP_2019_NA0001_55_113_20190307_00101.jpg

LM Start	8.55	Rating **	U	Issue No.	113
LM End	8.55	Issue Type +	En	Location *	LS
Category	Earthen Levee			GPS Latitude/Longitude	
				Start	End
Item	Vegetation			38.563963 °	38.563963 °
				-121.388135 °	-121.388135 °
DWR ID	DWR_NA0001_04_s_2012_113				
Comment Code					
V6 : Landscaping					
Inspector Comment

03/16/2012 Landscaping on chainlink fence blocks visibility and access.

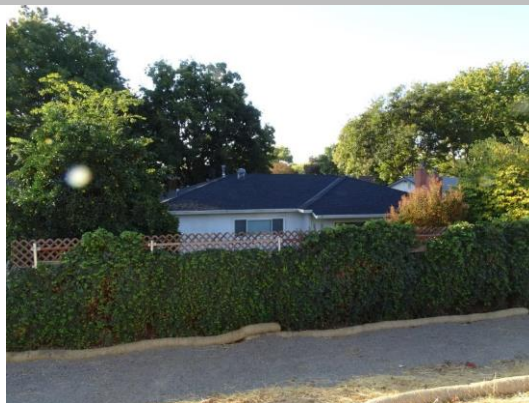
Photo 1 of 2 : SP_2019_NA0001_55_114_20190307_00102.jpg

LM Start	8.57	Rating **	U	Issue No.	114
LM End	8.57	Issue Type +	En	Location *	LS
Category	Earthen Levee			GPS Latitude/Longitude	
				Start	End
Item	Vegetation			38.564020 °	38.564020 °
				-121.387887 °	-121.387887 °
DWR ID	DWR_NA0001_04_s_2012_114				
Comment Code					
V6 : Landscaping					
Inspector Comment					
Ivy on a fence and an orange tree obstruct visibility.

View of fence with added lattice that obstructs visibility and access. Fall 2018

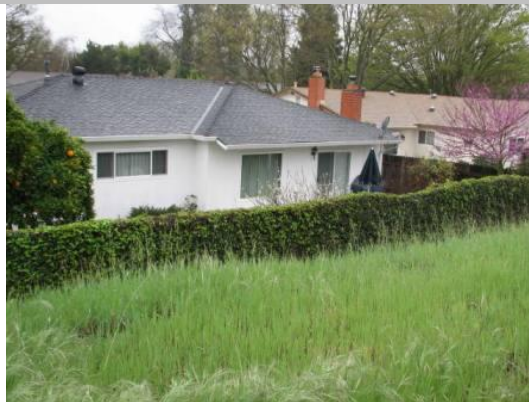
Photo 2 of 2 : SP_2019_NA0001_55_114_20190307_00103.jpg

LM Start	8.57	Rating **	U	Issue No.	114 (cont)
LM End	8.57	Issue Type +	En	Location *	LS

03/16/2012 Ivy on chainlink fence completely obstructs visibility and access.

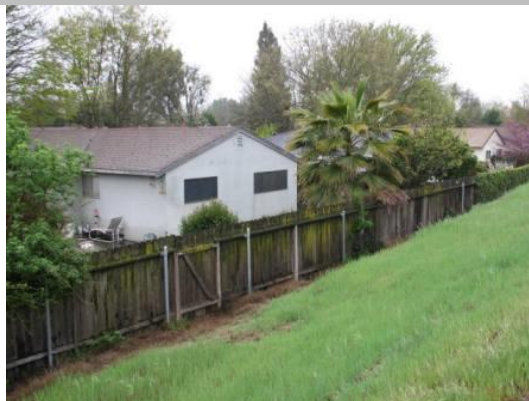
Photo 1 of 1 : SP_2019_NA0001_55_115_20190307_00104.jpg

LM Start	8.58	Rating **	U	Issue No.	115
LM End	8.58	Issue Type +	En	Location *	LS
Category	Earthen Levee			GPS Latitude/Longitude	
				Start	End
Item	Encroachments			38.564047 °	38.564047 °
				-121.387743 °	-121.387743 °
DWR ID	DWR_NA0001_04_s_2012_115				
Comment Code					
FE : Fence					
Inspector Comment					
Wood privacy fence within 10-ft of levee toe obstructs access and visibility.

03/16/2012 Wood privacy fence completely obstructs access and visibility.

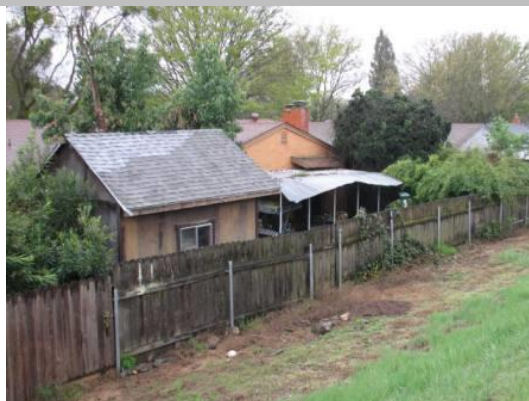
Photo 1 of 1 : SP_2019_NA0001_55_117_20190307_00106.jpg

LM Start	8.59	Rating **	U	Issue No.	117
LM End	8.59	Issue Type +	En	Location *	LS
Category	Earthen Levee			GPS Latitude/Longitude	
				Start	End
Item	Encroachments			38.564094 °	38.564094 °
				-121.387498 °	-121.387498 °
DWR ID	DWR_NA0001_04_s_2012_117				
Comment Code					
FE : Fence					
Inspector Comment					
Wood privacy fence within 10-ft of levee toe obstructs access and visibility.

03/16/2012 Wood privacy fence completely obstructs access and visibility.

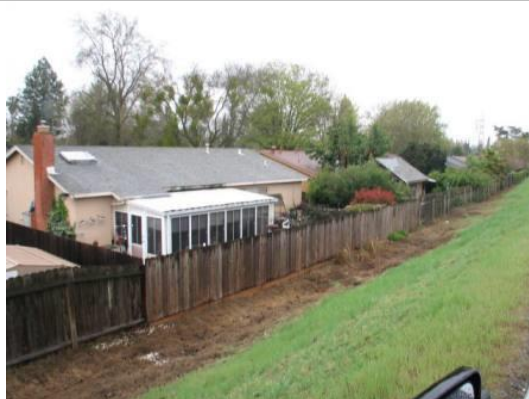
Photo 1 of 1 : SP_2019_NA0001_55_116_20190307_00105.jpg

LM Start	8.60	Rating **	U	Issue No.	116
LM End	8.60	Issue Type +	En	Location *	LS
Category	Earthen Levee			GPS Latitude/Longitude	
				Start	End
Item	Encroachments			38.564133 °	38.564133 °
				-121.387318 °	-121.387318 °
DWR ID	DWR_NA0001_04_s_2012_116				
Comment Code					
FE : Fence					
Inspector Comment					
Wood privacy fence within 10-ft of levee toe obstructs access and visibility.

03/16/2012 Wood privacy fence completely obstructs access and visibility.

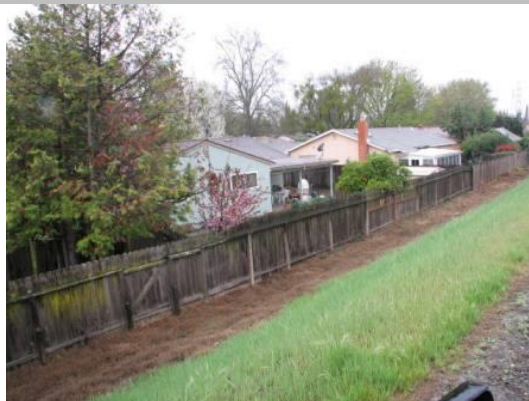
Photo 1 of 1 : SP_2019_NA0001_55_118_20190307_00107.jpg

LM Start	8.61	Rating **	U	Issue No.	118	
LM End	8.61	Issue Type +	En	Location *	LS	
Category	Earthen Levee			GPS Latitude/Longitude		
				Start	End	
Item	Encroachments			38.564133	°	38.564133
				-121.387092	°	-121.387092
DWR ID	DWR_NA0001_04_s_2018_118					
Comment Code						
FE : Fence						
Inspector Comment						
Wood privacy fence within 10-ft of levee toe obstructs access and visibility.

03/16/2012 Wood privacy fence completely obstructs access and visibility.

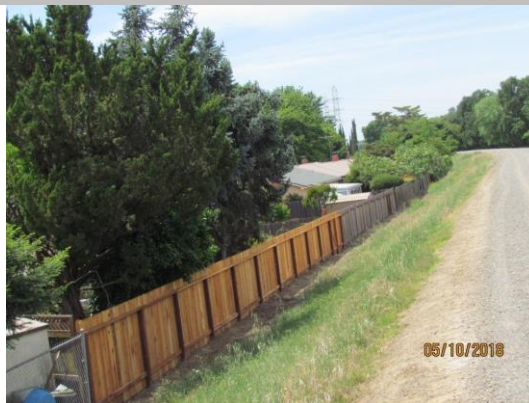
Photo 1 of 1 : SP_2019_NA0001_55_119_20190307_00108.jpg

LM Start	8.63	Rating **	U	Issue No.	119
LM End	8.63	Issue Type +	En	Location *	LS
Category	Earthen Levee			GPS Latitude/Longitude	
				Start	End
Item	Encroachments			38.564217 °	38.564217 °
				-121.386846 °	-121.386846 °
DWR ID	DWR_NA0001_04_s_2012_119				
Comment Code					
FE : Fence					
Inspector Comment					
Wood privacy fence still completely obstructs access and visibility.

New wood privacy fence still completely obstructs access and visibility, Spring 2018.

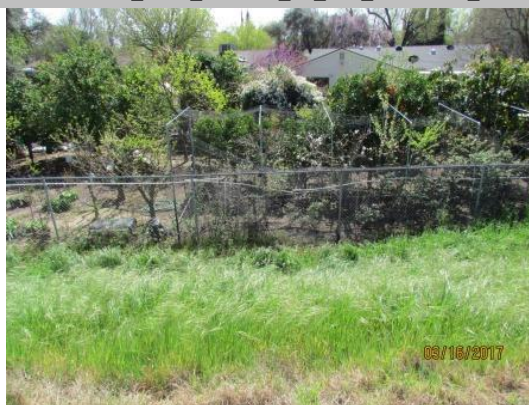
Photo 1 of 1 : SP_2019_NA0001_55_254_20190307_00199.jpg

LM Start	8.64	Rating **	M	Issue No.	254	
LM End	8.65	Issue Type +	En	Location *	LS	
Category	Earthen Levee			GPS Latitude/Longitude		
				Start	End	
Item	Encroachments			38.564257 °	38.564330 °	
				-121.386543 °	-121.386398 °	
DWR ID	DWR_NA0001_04_s_2017_254					
Comment Code						
FE : Fence						
Inspector Comment						
Chain link fence blocks access.

View of the fence at the levee toe.

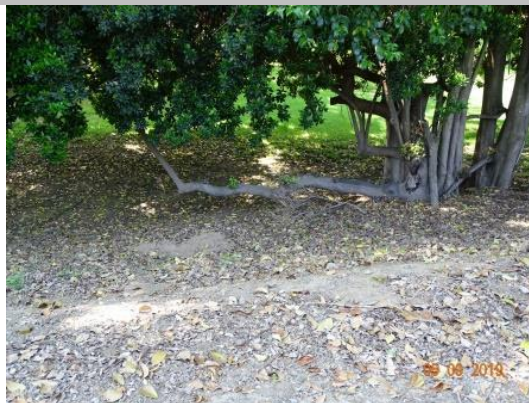
Photo 1 of 1 : SP_2019_NA0001_55_255_20190515_00268.jpg

LM Start	8.71	Rating **	M	Issue No.	255
LM End	8.73	Issue Type +	Ma	Location *	LS
Category	Earthen Levee			GPS Latitude/Longitude	
				Start	End
Item	Animal Control			38.564483 °	38.564530 °
				-121.385365 °	-121.385015 °
DWR ID	DWR_NA0001_04_s _ 2019_255				
Comment Code					
A1 : Exterminate rodents and backfill and compact or grout burrows.					
Inspector Comment					
Backfill animal holes on levee slope.

View looking south at animal holes on the levee slope. Spring 2019

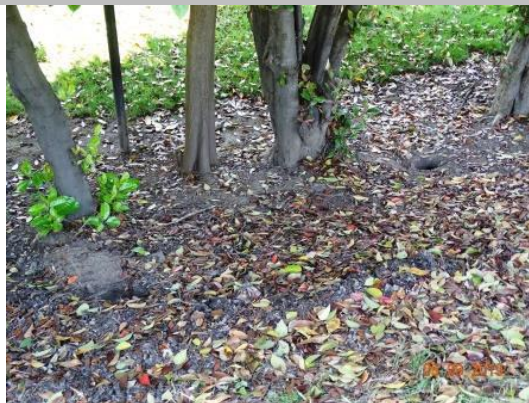
Photo 1 of 1 : SP_2019_NA0001_55_249_20190515_00267.jpg

LM Start	8.77	Rating **	M	Issue No.	249
LM End	8.77	Issue Type +	Ma	Location *	LS
Category	Earthen Levee			GPS Latitude/Longitude	
				Start	End
Item	Animal Control			38.564700 °	38.564700 °
				-121.384197 °	-121.384197 °
DWR ID	DWR_NA0001_04_s _ 2019_249				
Comment Code					
A3 : No rodents visible, but rodent burrows visible; need to backfill and compact or grout burrows.					
Inspector Comment					
Backfill two large animal holes at levee toe and one small hole at the shoulder.

View looking south at large animal holes on the levee slope. Spring 2019

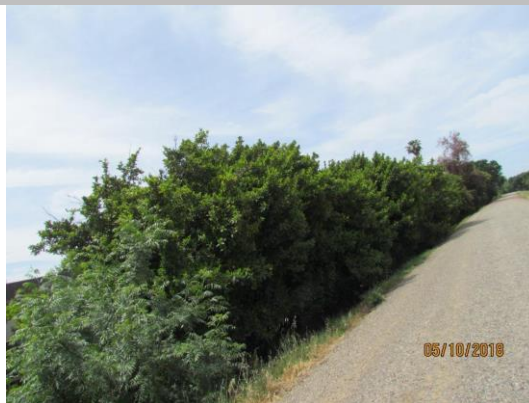
Photo 1 of 1 : SP_2019_NA0001_55_251_20190307_00197.jpg

LM Start	8.81	Rating **	M	Issue No.	251
LM End	8.83	Issue Type +	En	Location *	LS
Category	Earthen Levee			GPS Latitude/Longitude	
				Start	End
Item	Encroachments			38.564824 °	38.564914 °
				-121.383619 °	-121.383249 °
DWR ID	DWR_NA0001_04_s_2018_251				
Comment Code					
TR : Tree or limb					
Inspector Comment					
Homeowners' landscape trees are blocking access and visibility.

View looking downstream of the home owners' landscape trees that are blocking access and visibility. Spring 2018

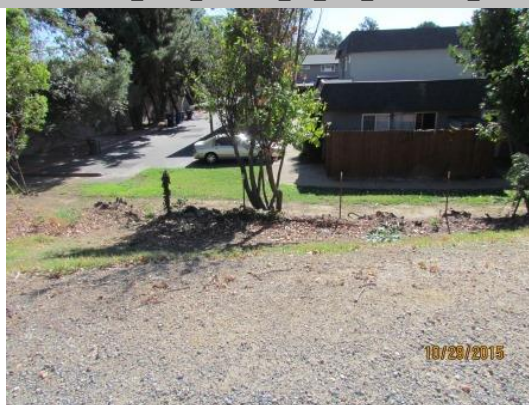
Photo 1 of 1 : SP_2019_NA0001_55_230_20190307_00188.jpg

LM Start	8.83	Rating **	N	Issue No.	230
LM End	8.83	Issue Type +	Ma	Location *	LS
Category	Earthen Levee			GPS Latitude/Longitude	
				Start	End
Item	Trim / Thin Trees			38.564929 °	38.564929 °
				-121.383248 °	-121.383248 °
DWR ID	DWR_NA0001_04_f_2015_230				
Comment Code					
T5 : Tree stumps.					
Inspector Comment					
There are five shrub stumps with multiple branches at this location.

View of the multiple tree stumps at the landside levee toe.

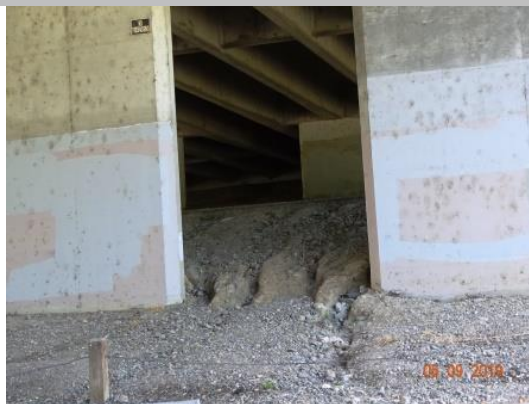
Photo 1 of 1 : SP_2019_NA0001_55_242_20190515_00266.jpg

LM Start	8.88	Rating **	M	Issue No.	242
LM End	8.88	Issue Type +	Ma	Location *	WS
Category	Earthen Levee			GPS Latitude/Longitude	
				Start	End
Item	Erosion / Bank Caving			38.565668 °	38.565668 °
				-121.382890 °	-121.382890 °
DWR ID	DWR_NA0001_04_s_2019_242				
Comment Code					
E2 : Schedule repair of erosion site prior to the next inspection.					
Inspector Comment					
Repair erosion rills underneath bridge.

View looking south at erosion rills underneath bridge. Spring 2019

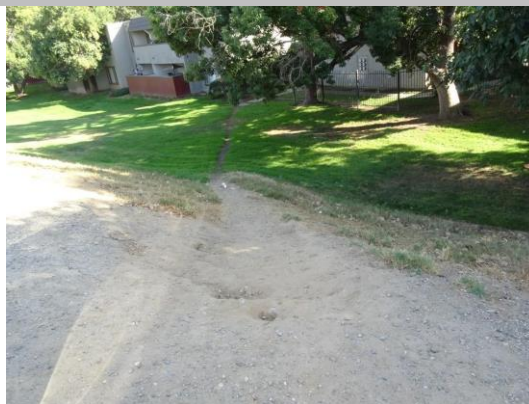
Photo 1 of 1 : SP_2019_NA0001_55_252_20190307_00198.jpg

LM Start	8.95	Rating **	A/W	Issue No.	252
LM End	8.95	Issue Type +	Ma	Location *	LS
Category	Earthen Levee			GPS Latitude/Longitude	
				Start	End
Item	Slope Stability			38.565696 °	38.565696 °
				-121.381141 °	-121.381141 °
DWR ID	DWR_NA0001_04_f_2018_252				
Comment Code					
S2 : Repair the levee slope damaged by foot traffic and prevent access where possible.					
Inspector Comment					
Monitor slope damage from foot traffic.

View of footpath on levee toe. Fall 2018

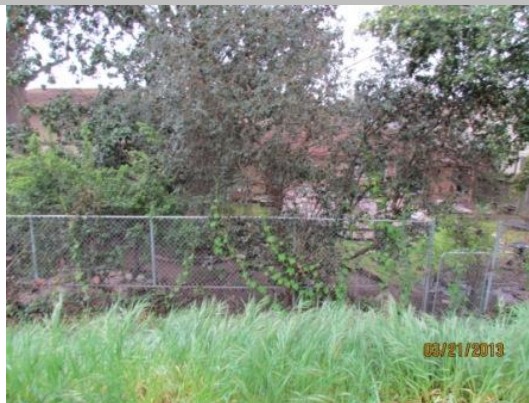
Photo 1 of 1 : SP_2019_NA0001_55_122_20190307_00109.jpg

LM Start	9.55	Rating **	M	Issue No.	122
LM End	9.55	Issue Type +	En	Location *	LS
Category	Earthen Levee			GPS Latitude/Longitude	
				Start	End
Item	Vegetation			38.567181 °	38.567181 °
				-121.370366 °	-121.370366 °
DWR ID	DWR_NA0001_04_s _ 2012_122				
Comment Code					
V6 : Landscaping					
Inspector Comment					
Trees and ground cover are within 10-ft of levee toe.

View of landscaping at levee toe.

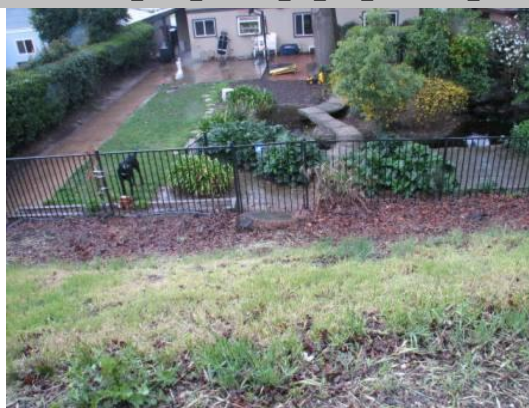
Photo 1 of 1 : SP_2019_NA0001_55_123_20190307_00110.jpg

LM Start	9.56	Rating **	N	Issue No.	123
LM End	9.56	Issue Type +	Ma	Location *	LS
Category	Earthen Levee			GPS Latitude/Longitude	
				Start	End
Item	Trim / Thin Trees			38.567246 °	38.567246 °
				-121.370146 °	-121.370146 °
DWR ID	DWR_NA0001_04_s _ 2012_123				
Comment Code					
T5 : Tree stumps.					
Inspector Comment					
Trees, tree stump, bushes, and ground cover are within 10-ft of levee toe.

03/16/2012 Large tree stump at levee toe.

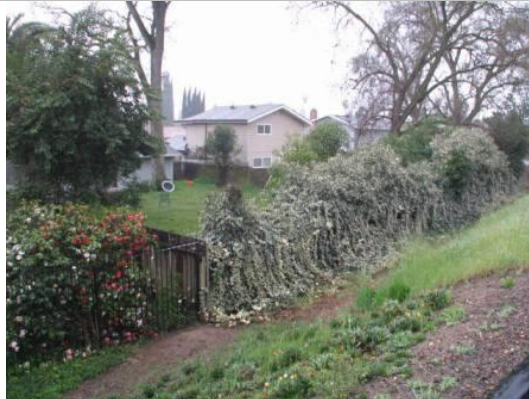
Photo 1 of 1 : SP_2019_NA0001_55_125_20190307_00111.jpg

LM Start	9.60	Rating **	U	Issue No.	125
LM End	9.60	Issue Type +	En	Location *	LS
Category	Earthen Levee			GPS Latitude/Longitude	
				Start	End
Item	Vegetation			38.567360 °	38.567360 °
				-121.369555 °	-121.369555 °
DWR ID	DWR_NA0001_04_s _ 2012_125				
Comment Code					
V6 : Landscaping					
Inspector Comment					
Dense golden ivy on chainlink fence obstructs access and visibility.

03/16/2012 Landscaping obstructs visibility and access.

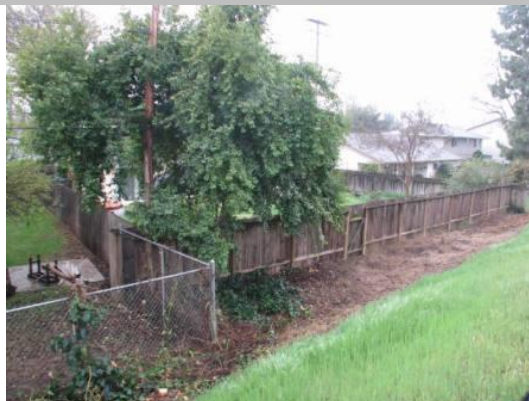
Photo 1 of 1 : SP_2019_NA0001_55_128_20190307_00112.jpg

LM Start	9.65	Rating **	U	Issue No.	128
LM End	9.65	Issue Type +	En	Location *	LS
Category	Earthen Levee			GPS Latitude/Longitude	
				Start	End
Item	Encroachments			38.567493 °	38.567493 °
				-121.368633 °	-121.368633 °
DWR ID	DWR_NA0001_04_s _ 2012_128				
Comment Code					
FE : Fence					
Inspector Comment					
Wooden privacy fence within 10-ft of levee toe obstructs visibility.

03/16/2012 Wood privacy fence completely obstructs visibility.

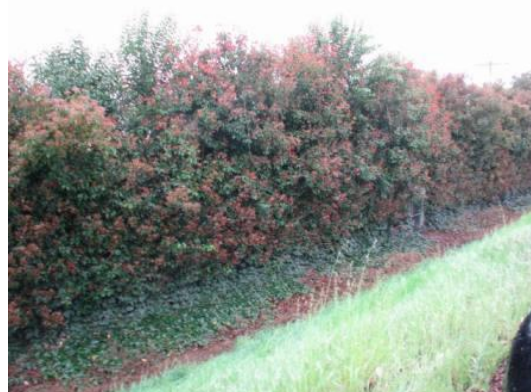
Photo 1 of 1 : SP_2019_NA0001_55_130_20190307_00113.jpg

LM Start	9.69	Rating **	U	Issue No.	130
LM End	9.69	Issue Type +	En	Location *	LS
Category	Earthen Levee			GPS Latitude/Longitude	
				Start	End
Item	Vegetation			38.567626 °	38.567626 °
				-121.367921 °	-121.367921 °
DWR ID	DWR_NA0001_04_s_2012_130				
Comment Code					
V6 : Landscaping					
Inspector Comment					
Tall hedge obstructs access and visibility.

03/16/2012 Tall hedge obstructs visibility and access.

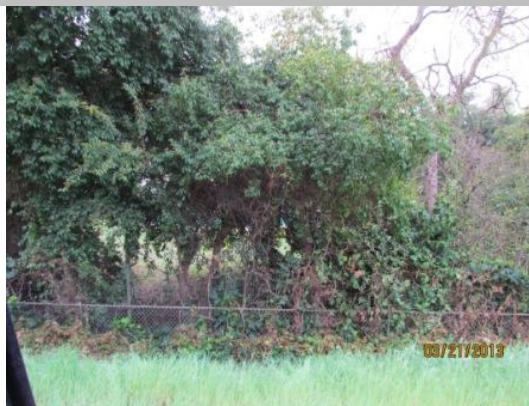
Photo 1 of 1 : SP_2019_NA0001_55_132_20190307_00114.jpg

LM Start	9.72	Rating **	M	Issue No.	132
LM End	9.72	Issue Type +	En	Location *	LS
Category	Earthen Levee			GPS Latitude/Longitude	
				Start	End
Item	Vegetation			38.567772 °	38.567772 °
				-121.367227 °	-121.367227 °
DWR ID	DWR_NA0001_04_s _ 2012_132				
Comment Code					
V6 : Landscaping					
Inspector Comment					
Trees and ivy on levee slope obstruct access and visibility.

View of obstructive landscaping.

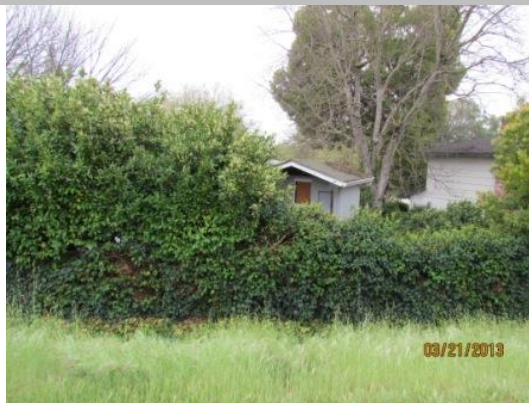
Photo 1 of 1 : SP_2019_NA0001_55_134_20190307_00115.jpg

LM Start	9.77	Rating **	U	Issue No.	134
LM End	9.77	Issue Type +	En	Location *	LS
Category	Earthen Levee			GPS Latitude/Longitude	
				Start	End
Item	Vegetation			38.567873 °	38.567873 °
				-121.366410 °	-121.366410 °
DWR ID	DWR_NA0001_04_s _ 2012_134				
Comment Code					
V6 : Landscaping					
Inspector Comment					
Ivy, hedge, and play house are within 10-ft of levee toe.

View of landscaping and playhouse that are within 10 ft. of levee toe.

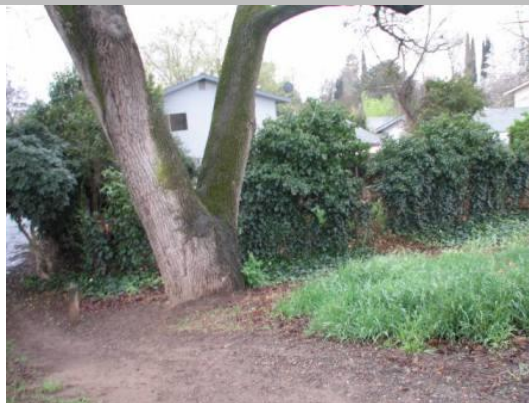
Photo 1 of 1 : SP_2019_NA0001_55_135_20190307_00116.jpg

LM Start	9.88	Rating **	U	Issue No.	135
LM End	9.88	Issue Type +	En	Location *	LS
Category	Earthen Levee			GPS Latitude/Longitude	
				Start	End
Item	Vegetation			38.568411 °	38.568411 °
				-121.364489 °	-121.364489 °
DWR ID	DWR_NA0001_04_s_2012_135				
Comment Code					
V6 : Landscaping					
Inspector Comment					
Tall hedge and ivy are within 10-ft of landside levee toe.

03/16/2012 Landscaping is obstructing visibility.

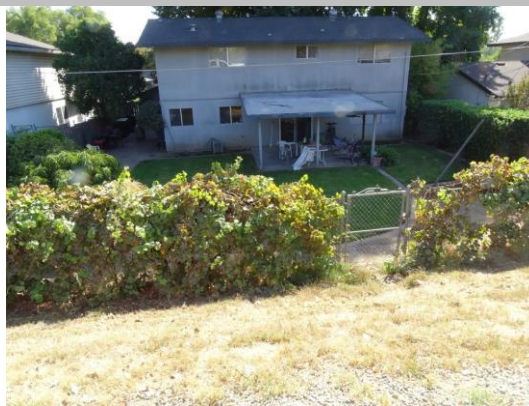
Photo 1 of 1 : SP_2019_NA0001_55_229_20190307_00187.jpg

LM Start	9.93	Rating **	M	Issue No.	229
LM End	9.93	Issue Type +	En	Location *	LS
Category	Earthen Levee			GPS Latitude/Longitude	
				Start	End
Item	Encroachments			38.568647 °	38.568647 °
				-121.363585 °	-121.363585 °
DWR ID	DWR_NA0001_04_s_2017_229				
Comment Code					
FE : Fence					
Inspector Comment					
Chainlink fence is blocking access.

View of landowner fence and vegetation blocking visibility and access.
Fall 2018

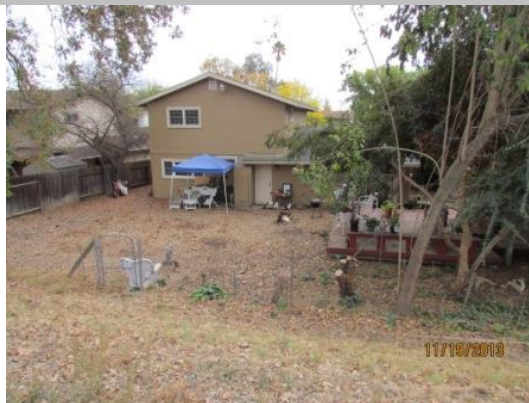
Photo 1 of 1 : SP_2019_NA0001_55_136_20190307_00117.jpg

LM Start	9.95	Rating **	M	Issue No.	136
LM End	9.95	Issue Type +	En	Location *	LS
Category	Earthen Levee			GPS Latitude/Longitude	
				Start	End
Item	Encroachments			38.568714 °	38.568714 °
				-121.363257 °	-121.363257 °
DWR ID	DWR_NA0001_04_s _ 2012_136				
Comment Code					
FE : Fence					
Inspector Comment					
Wire fence and vegetation are within 10-ft of landside levee toe.

View of the fence and tree stump at the landside levee toe.

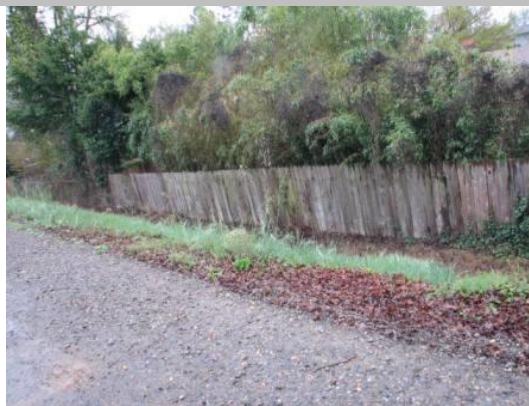
Photo 1 of 1 : SP_2019_NA0001_55_138_20190307_00118.jpg

LM Start	10.00	Rating **	U	Issue No.	138
LM End	10.00	Issue Type +	En	Location *	LS
Category	Earthen Levee			GPS Latitude/Longitude	
				Start	End
Item	Encroachments			38.568953 °	38.568953 °
				-121.362396 °	-121.362396 °
DWR ID	DWR_NA0001_04_s _ 2012_138				
Comment Code					
FE : Fence					
Inspector Comment					
Wood privacy fence completely obstructs visibility and access.

03/16/2012 Wood privacy fence completely obstructs access and visibility.

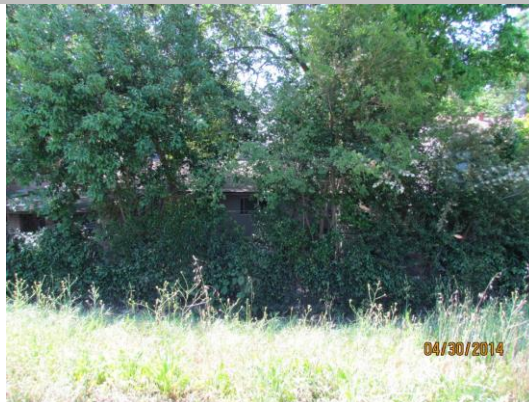
Photo 1 of 1 : SP_2019_NA0001_55_245_20190307_00195.jpg

LM Start	10.06	Rating **	U	Issue No.	245
LM End	10.06	Issue Type +	En	Location *	LS
Category	Earthen Levee			GPS Latitude/Longitude	
				Start	End
Item	Encroachments			38.569247 °	38.569247 °
				-121.361315 °	-121.361315 °
DWR ID	DWR_NA0001_04_s _ 2014_245				
Comment Code					
FE : Fence					
Inspector Comment					
Rod fence covered with vegetation is within 10ft of the levee toe.

View of the fence at the landside levee toe.

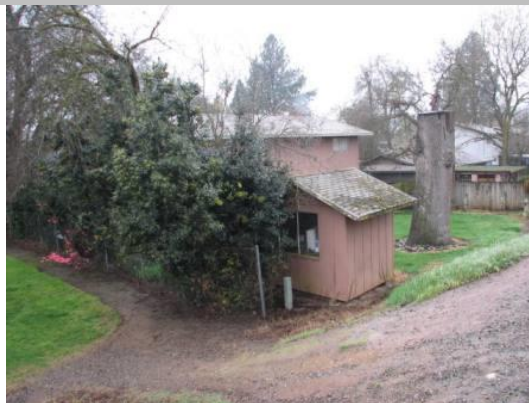
Photo 1 of 1 : SP_2019_NA0001_55_176_20190307_00152.jpg

LM Start	10.08	Rating **	U	Issue No.	176
LM End	10.08	Issue Type +	En	Location *	LS
Category	Earthen Levee			GPS Latitude/Longitude	
				Start	End
Item	Encroachments			38.569293 °	38.569293 °
				-121.361002 °	-121.361002 °
DWR ID	DWR_NA0001_04_s_2012_176				
Comment Code					
BU : Building					
Inspector Comment

03/16/2012 Wood structure within 15' of levee toe.

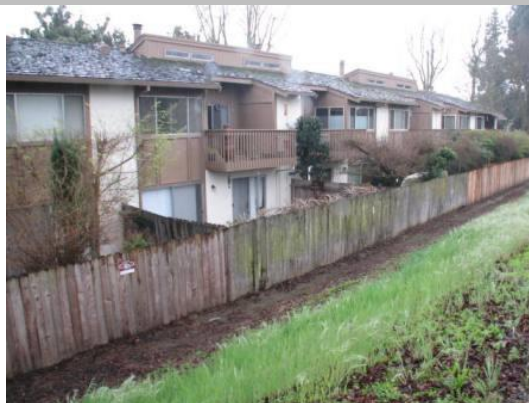
Photo 1 of 1 : SP_2019_NA0001_55_141_20190307_00120.jpg

LM Start	10.24	Rating **	U	Issue No.	141
LM End	10.27	Issue Type +	En	Location *	LS
Category	Earthen Levee			GPS Latitude/Longitude	
				Start	End
Item	Encroachments			38.569982 °	38.570118 °
				-121.358134 °	-121.357604 °
DWR ID	DWR_NA0001_04_s_2012_141				
Comment Code					
FE : Fence					
Inspector Comment					
Wooden fence behind six apartment units is within 10-ft of levee slope.

03/16/2012 Wood privacy fence completely obstructs access and visibility.

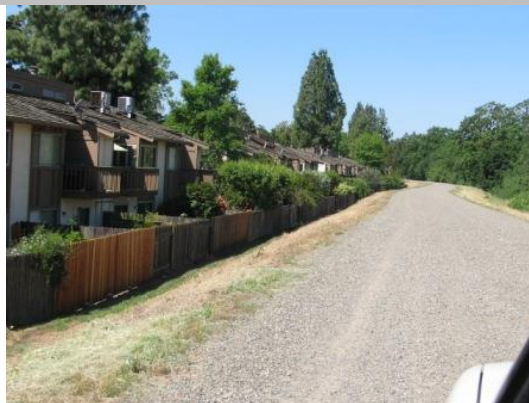
Photo 1 of 1 : SP_2019_NA0001_55_142_20190307_00121.jpg

LM Start	10.28	Rating **	U	Issue No.	142
LM End	10.30	Issue Type +	En	Location *	LS
Category	Earthen Levee			GPS Latitude/Longitude	
				Start	End
Item	Encroachments			38.570175 °	38.570229 °
				-121.357390 °	-121.357041 °
DWR ID	DWR_NA0001_04_s_2017_142				
Comment Code					
FE : Fence					
Inspector Comment					
Wooden fence behind six apartment units is within 10-ft of levee slope.

Wooden fence behind apartments is within 10' of levee toe.

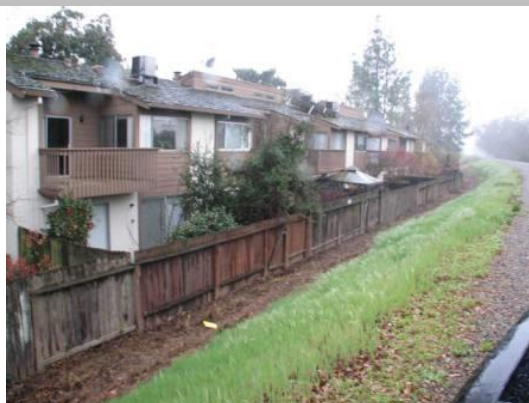
Photo 1 of 1 : SP_2019_NA0001_55_146_20190307_00125.jpg

LM Start	10.30	Rating **	U	Issue No.	146
LM End	10.32	Issue Type +	En	Location *	LS
Category	Earthen Levee			GPS Latitude/Longitude	
				Start	End
Item	Encroachments			38.570225 °	38.570245 °
				-121.357014 °	-121.356791 °
DWR ID	DWR_NA0001_04_s_2012_146				
Comment Code					
FE : Fence					
Inspector Comment					
Wooden fence behind six apartment units is within 10-ft of levee slope.

03/16/2012 Wood privacy fence completely obstructs access and visibility.

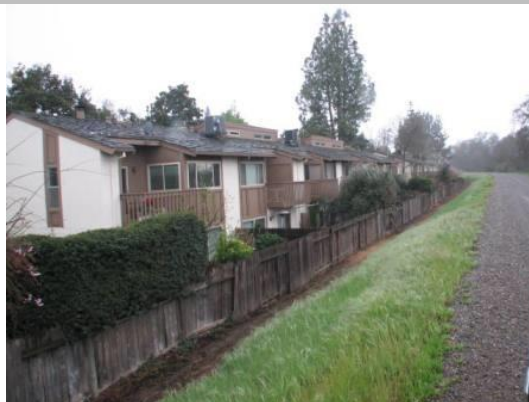
Photo 1 of 1 : SP_2019_NA0001_55_143_20190307_00122.jpg

LM Start	10.32	Rating **	U	Issue No.	143
LM End	10.34	Issue Type +	En	Location *	LS
Category	Earthen Levee			GPS Latitude/Longitude	
				Start	End
Item	Encroachments			38.570257 °	38.570297 °
				-121.356783 °	-121.356403 °
DWR ID	DWR_NA0001_04_f_2018_143				
Comment Code					
FE : Fence					
Inspector Comment					
Wooden fence behind six apartment units is within 10-ft of levee slope.

03/16/2012 Wood privacy fence completely obstructs access and visibility.

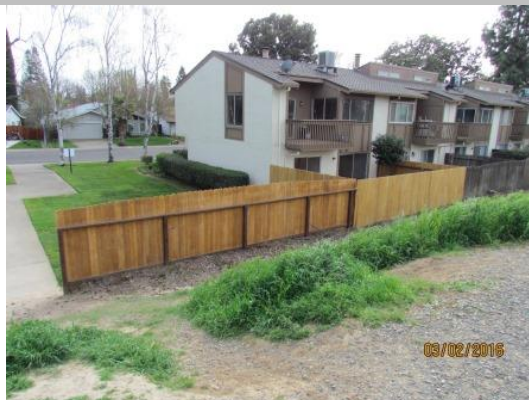
Photo 1 of 1 : SP_2019_NA0001_55_145_20190307_00124.jpg

LM Start	10.38	Rating **	U	Issue No.	145
LM End	10.41	Issue Type +	En	Location *	LS
Category	Earthen Levee			GPS Latitude/Longitude	
				Start	End
Item	Encroachments			38.570417 °	38.570500 °
				-121.355625 °	-121.355151 °
DWR ID	DWR_NA0001_04_s_2012_145				
Comment Code					
FE : Fence					
Inspector Comment					
Wooden fence behind six apartment units is within 10-ft of levee slope.

Wood privacy fence completely obstructs access and visibility.

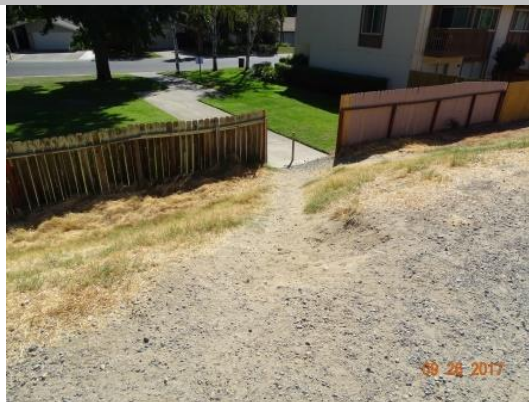
Photo 1 of 1 : SP_2019_NA0001_55_228_20190307_00186.jpg

LM Start	10.42	Rating **	A/W	Issue No.	228
LM End	10.42	Issue Type +	Ma	Location *	LS
Category	Earthen Levee			GPS Latitude/Longitude	
				Start	End
Item	Slope Stability			38.570536 °	38.570536 °
				-121.354957 °	-121.354957 °
DWR ID	DWR_NA0001_04_s_2016_228				
Comment Code					
S2 : Repair the levee slope damaged by foot traffic and prevent access where possible.					
Inspector Comment					
The erosion of the levee slope from the footpath appears to be stable at this time and should be monitored.

View of the footpath on the levee slope.

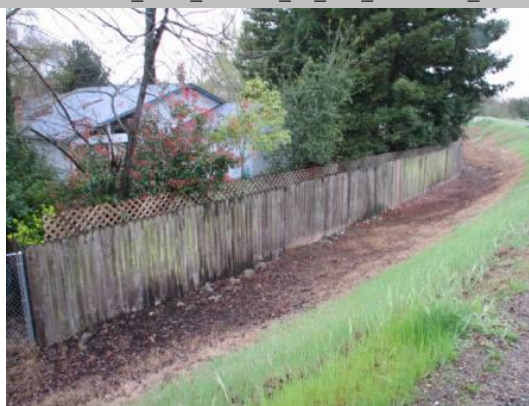
Photo 1 of 1 : SP_2019_NA0001_55_148_20190307_00127.jpg

LM Start	10.45	Rating **	U	Issue No.	148
LM End	10.45	Issue Type +	En	Location *	LS
Category	Earthen Levee			GPS Latitude/Longitude	
				Start	End
Item	Encroachments			38.570524 °	38.570524 °
				-121.354359 °	-121.354359 °
DWR ID	DWR_NA0001_04_s_2012_148				
Comment Code					
FE : Fence					
Inspector Comment					
Wooden privacy fence obstructs visibility and access.

03/16/2012 Wood privacy fence completely obstructs access and visibility.

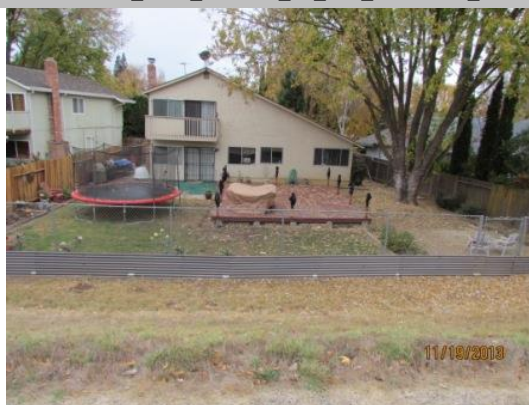
Photo 1 of 1 : SP_2019_NA0001_55_180_20190307_00155.jpg

LM Start	10.47	Rating **	M	Issue No.	180
LM End	10.47	Issue Type +	En	Location *	LS
Category	Earthen Levee			GPS Latitude/Longitude	
				Start	End
Item	Encroachments			38.570397 °	38.570397 °
				-121.354084 °	-121.354084 °
DWR ID	DWR_NA0001_04_s_2012_180				
Comment Code					
FE : Fence					
Inspector Comment					
Chainlink fence partially obstructs visibility.

Chainlink fence is partially obstructing visibility and access. Fall 2013

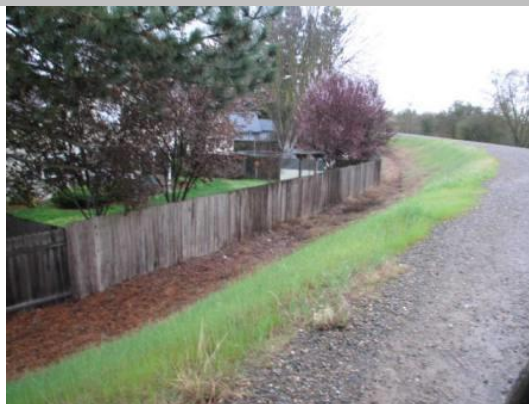
Photo 1 of 1 : SP_2019_NA0001_55_149_20190307_00128.jpg

LM Start	10.48	Rating **	U	Issue No.	149
LM End	10.48	Issue Type +	En	Location *	LS
Category	Earthen Levee			GPS Latitude/Longitude	
				Start	End
Item	Encroachments			38.570234 °	38.570234 °
				-121.353862 °	-121.353862 °
DWR ID	DWR_NA0001_04_s_2012_149				
Comment Code					
FE : Fence					
Inspector Comment					
Wooden privacy fence is within 10-ft of levee toe.

03/16/2012 Wood privacy fence completely obstructs access and visibility.

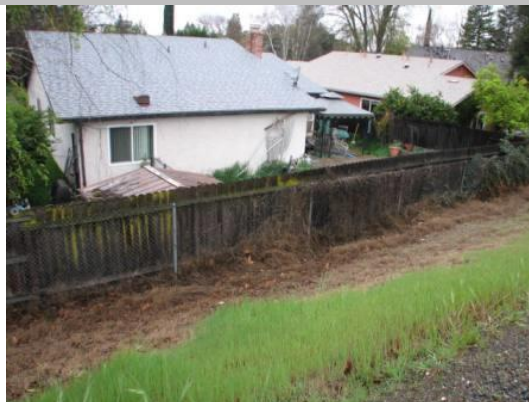
Photo 1 of 1 : SP_2019_NA0001_55_151_20190307_00130.jpg

LM Start	10.51	Rating **	U	Issue No.	151
LM End	10.51	Issue Type +	En	Location *	LS
Category	Earthen Levee			GPS Latitude/Longitude	
				Start	End
Item	Encroachments			38.569921 °	38.569921 °
				-121.353643 °	-121.353643 °
DWR ID	DWR_NA0001_04_s _ 2012_151				
Comment Code					
FE : Fence					
Inspector Comment					
Wooden privacy fence is within 10-ft of levee toe.

03/16/2012 Wood privacy fence completely obstructs access and visibility.

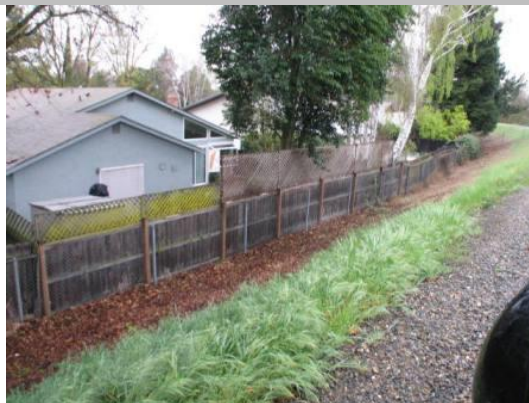
Photo 1 of 1 : SP_2019_NA0001_55_152_20190307_00131.jpg

LM Start	10.52	Rating **	U	Issue No.	152
LM End	10.52	Issue Type +	En	Location *	LS
Category	Earthen Levee			GPS Latitude/Longitude	
				Start	End
Item	Encroachments			38.569758 °	38.569758 °
				-121.353535 °	-121.353535 °
DWR ID	DWR_NA0001_04_s_2012_152				
Comment Code					
FE : Fence					
Inspector Comment					
Wooden privacy fence within 10-ft of levee toe.

03/16/2012 Wood privacy fence completely obstructs access and visibility.

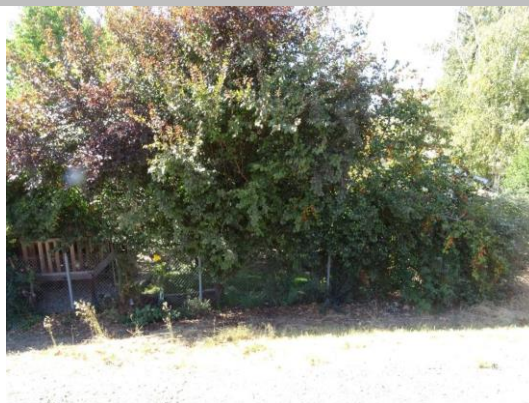
Photo 1 of 1 : SP_2019_NA0001_55_217_20190307_00180.jpg

LM Start	10.56	Rating **	M	Issue No.	217
LM End	10.56	Issue Type +	En	Location *	LS
Category	Earthen Levee			GPS Latitude/Longitude	
				Start	End
Item	Vegetation			38.569296 °	38.569296 °
				-121.353365 °	-121.353365 °
DWR ID	DWR_NA0001_04_f_2018_217				
Comment Code					
V6 : Landscaping					
Inspector Comment					
Trees and bushes block visibility of levee toe. The shed is also on the levee toe.

View of landowner vegetation blocking visibility of levee toe. Fall 2018

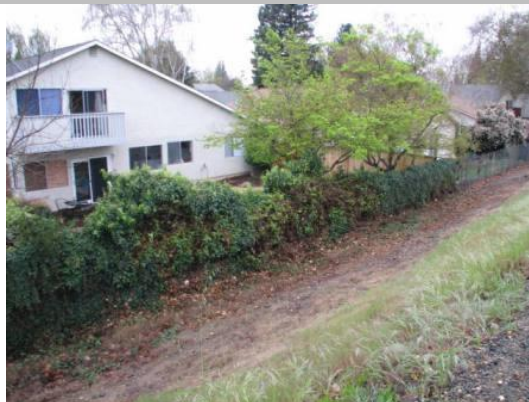
Photo 1 of 1 : SP_2019_NA0001_55_153_20190307_00132.jpg

LM Start	10.57	Rating **	U	Issue No.	153
LM End	10.57	Issue Type +	En	Location *	LS
Category	Earthen Levee			GPS Latitude/Longitude	
				Start	End
Item	Encroachments			38.569166 °	38.569166 °
				-121.353272 °	-121.353272 °
DWR ID	DWR_NA0001_04_s_2012_153				
Comment Code					
FE : Fence					
Inspector Comment					
Wooden privacy fence and ivy within 10-ft of levee toe.

03/16/2012 Wood privacy fence completely obstructs access and visibility.

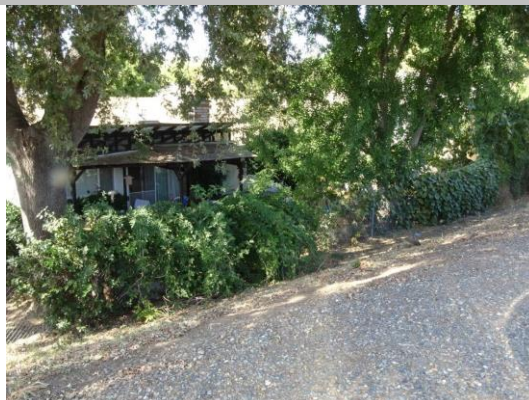
Photo 1 of 1 : SP_2019_NA0001_55_155_20190307_00134.jpg

LM Start	10.59	Rating **	M	Issue No.	155
LM End	10.59	Issue Type +	En	Location *	LS
Category	Earthen Levee			GPS Latitude/Longitude	
				Start	End
Item	Vegetation			38.568892 °	38.568892 °
				-121.353162 °	-121.353162 °
DWR ID	DWR_NA0001_04_s_2019_155				
Comment Code					
V6 : Landscaping					
Inspector Comment					
Trees and bushes are within 10-ft of the levee toe and block visibility.

View of tree and bushes within levee easement. Fall 2018

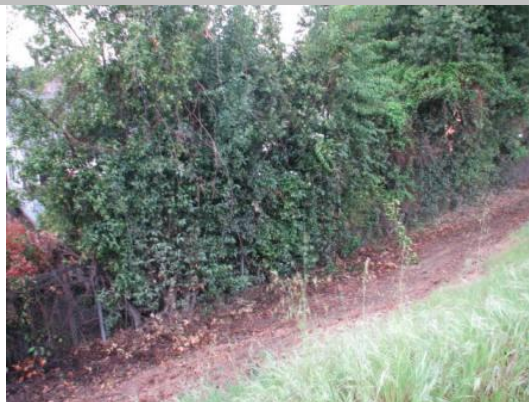
Photo 1 of 1 : SP_2019_NA0001_55_157_20190307_00136.jpg

LM Start	10.61	Rating **	M	Issue No.	157
LM End	10.61	Issue Type +	En	Location *	LS
Category	Earthen Levee			GPS Latitude/Longitude	
				Start	End
Item	Vegetation			38.568608 °	38.568608 °
				-121.353054 °	-121.353054 °
DWR ID	DWR_NA0001_04_s_2012_157				
Comment Code					
V6 : Landscaping					
Inspector Comment					
Tall hedge and vines are on the levee toe.

03/16/2012 Landscaping obstructs visibility.

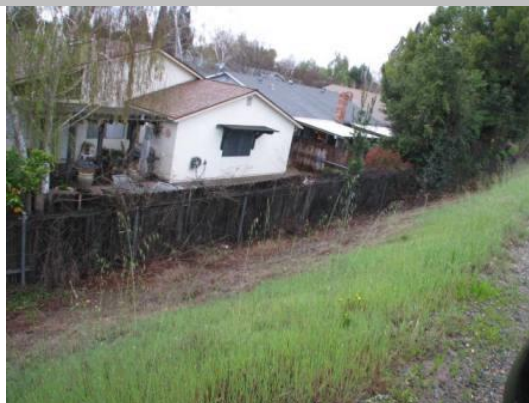
Photo 1 of 1 : SP_2019_NA0001_55_158_20190307_00137.jpg

LM Start	10.62	Rating **	U	Issue No.	158
LM End	10.62	Issue Type +	En	Location *	LS
Category	Earthen Levee			GPS Latitude/Longitude	
				Start	End
Item	Encroachments			38.568355 °	38.568355 °
				-121.353033 °	-121.353033 °
DWR ID	DWR_NA0001_04_s _ 2012_158				
Comment Code					
FE : Fence					
Inspector Comment					
Wooden privacy fence within 10-ft of levee toe.

03/16/2012 Wood privacy fence completely obstructs access and visibility.

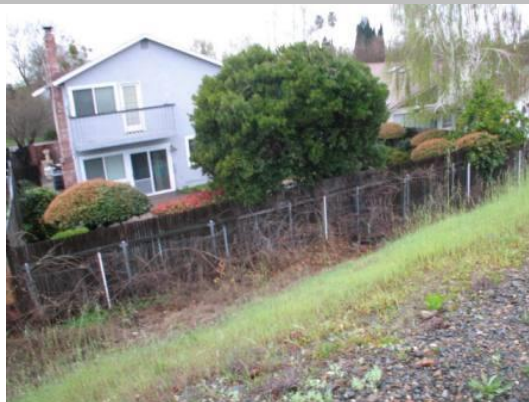
Photo 1 of 1 : SP_2019_NA0001_55_159_20190307_00138.jpg

LM Start	10.63	Rating **	U	Issue No.	159
LM End	10.63	Issue Type +	En	Location *	LS
Category	Earthen Levee			GPS Latitude/Longitude	
				Start	End
Item	Encroachments			38.568313 °	38.568313 °
				-121.352941 °	-121.352941 °
DWR ID	DWR_NA0001_04_s _ 2012_159				
Comment Code					
FE : Fence					
Inspector Comment					
Wooden privacy fence within 10-ft of levee toe.

03/16/2012 Wood privacy fence completely obstructs access and visibility.

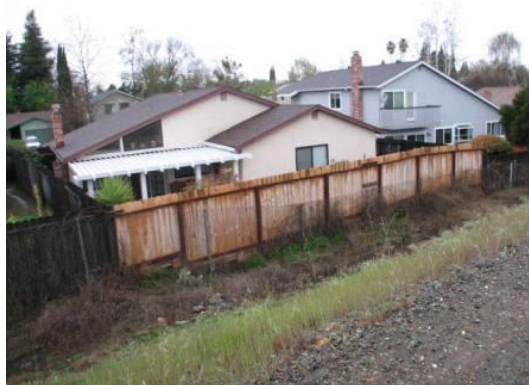
Photo 1 of 1 : SP_2019_NA0001_55_160_20190307_00139.jpg

LM Start	10.64	Rating **	U	Issue No.	160
LM End	10.64	Issue Type +	En	Location *	LS
Category	Earthen Levee			GPS Latitude/Longitude	
				Start	End
Item	Encroachments			38.568188 °	38.568188 °
				-121.352864 °	-121.352864 °
DWR ID	DWR_NA0001_04_f_2012_160				
Comment Code					
FE : Fence					
Inspector Comment					
Tall wooden privacy fence within 10-ft of levee toe.

03/16/2012 Wood privacy fence completely obstructs access and visibility.

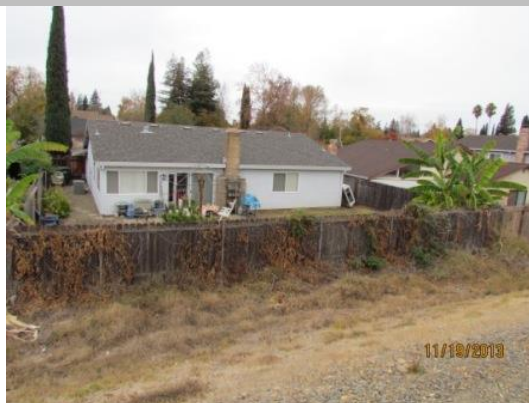
Photo 1 of 1 : SP_2019_NA0001_55_161_20190307_00140.jpg

LM Start	10.65	Rating **	U	Issue No.	161
LM End	10.65	Issue Type +	En	Location *	LS
Category	Earthen Levee			GPS Latitude/Longitude	
				Start	End
Item	Encroachments			38.568058 °	38.568058 °
				-121.352785 °	-121.352785 °
DWR ID	DWR_NA0001_04_s_2012_161				
Comment Code					
FE : Fence					
Inspector Comment					
Wooden privacy fence within 10-ft of levee toe.

View of wood privacy fence completely obstructing access and visibility.

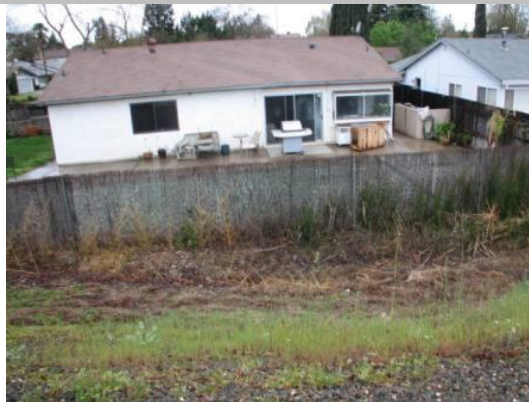
Photo 1 of 1 : SP_2019_NA0001_55_179_20190307_00154.jpg

LM Start	10.66	Rating **	U	Issue No.	179
LM End	10.66	Issue Type +	En	Location *	LS
Category	Earthen Levee			GPS Latitude/Longitude	
				Start	End
Item	Encroachments			38.567917 °	38.567917 °
				-121.352698 °	-121.352698 °
DWR ID	DWR_NA0001_04_s_2012_179				
Comment Code					
FE : Fence					
Inspector Comment					
Chainlink fence with bamboo mats prevent visibility.

03/16/2012 Bamboo panels on chainlink fence completely obstruct visibility.

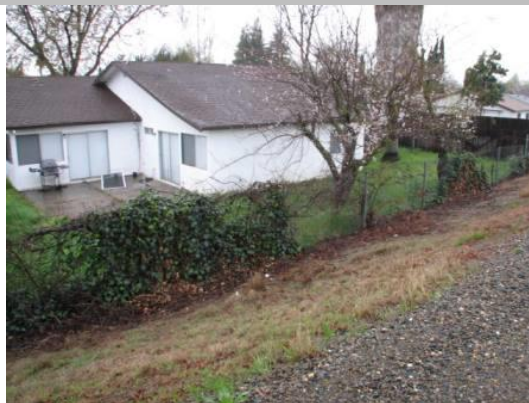
Photo 1 of 1 : SP_2019_NA0001_55_178_20190307_00153.jpg

LM Start	10.68	Rating **	M	Issue No.	178
LM End	10.68	Issue Type +	En	Location *	LS
Category	Earthen Levee			GPS Latitude/Longitude	
				Start	End
Item	Encroachments			38.567552 °	38.567552 °
				-121.352500 °	-121.352500 °
DWR ID	DWR_NA0001_04_s_2012_178				
Comment Code					
FE : Fence					
Inspector Comment					
Chainlink fence at levee toe partially blocks visibility.

03/16/2012 Chainlink fence partially blocks visibility.

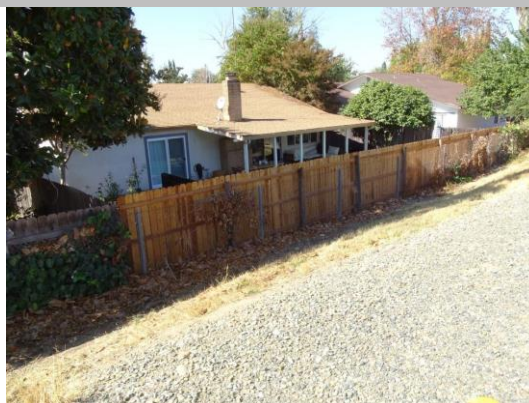
Photo 1 of 1 : SP_2019_NA0001_55_162_20190307_00141.jpg

LM Start	10.70	Rating **	U	Issue No.	162
LM End	10.70	Issue Type +	En	Location *	LS
Category	Earthen Levee			GPS Latitude/Longitude	
				Start	End
Item	Encroachments			38.567402 °	38.567402 °
				-121.352415 °	-121.352415 °
DWR ID	DWR_NA0001_04_s_2012_162				
Comment Code					
FE : Fence					
Inspector Comment					
Wooden and chainlink fences within 10-ft of levee toe.

View of wooden fence at levee toe that blocks visibility. Fall 2018

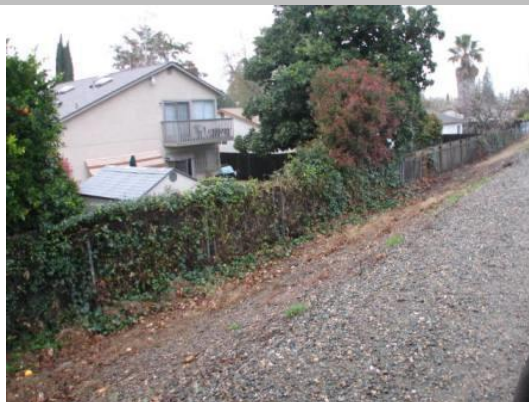
Photo 1 of 1 : SP_2019_NA0001_55_163_20190307_00143.jpg

LM Start	10.71	Rating **	U	Issue No.	163
LM End	10.71	Issue Type +	En	Location *	LS
Category	Earthen Levee			GPS Latitude/Longitude	
				Start	End
Item	Encroachments			38.567250 °	38.567250 °
				-121.352341 °	-121.352341 °
DWR ID	DWR_NA0001_04_s_2012_163				
Comment Code					
FE : Fence					
Inspector Comment					
Wooden privacy fence and landscaping within 10-ft of levee toe.

03/16/2012 Wood privacy fence completely obstructs access and visibility.

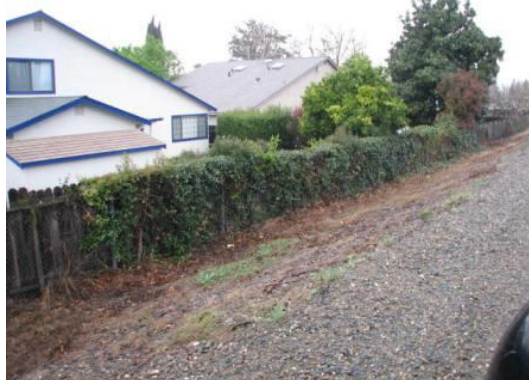
Photo 1 of 1 : SP_2019_NA0001_55_172_20190307_00151.jpg

LM Start	10.72	Rating **	U	Issue No.	172
LM End	10.72	Issue Type +	En	Location *	LS
Category	Earthen Levee			GPS Latitude/Longitude	
				Start	End
Item	Encroachments			38.567008 °	38.567008 °
				-121.352226 °	-121.352226 °
DWR ID	DWR_NA0001_04_s_2012_172				
Comment Code					
FE : Fence					
Inspector Comment					
Wooden privacy fence obstructs access and visibility.

03/16/2012 Wood privacy fence completely obstructs access and visibility.

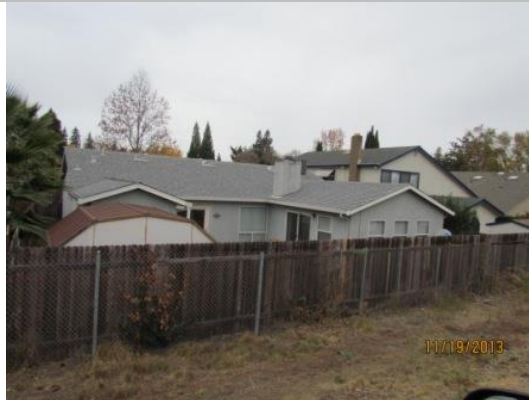
Photo 1 of 1 : SP_2019_NA0001_55_170_20190307_00149.jpg

LM Start	10.73	Rating **	U	Issue No.	170
LM End	10.73	Issue Type +	En	Location *	LS
Category	Earthen Levee			GPS Latitude/Longitude	
				Start	End
Item	Encroachments			38.566981 °	38.566981 °
				-121.352213 °	-121.352213 °
DWR ID	DWR_NA0001_04_f_2012_170				
Comment Code					
FE : Fence					
Inspector Comment					
Wooden privacy fence within 10-ft of levee toe.

View of the fence obstructing visibility and access.

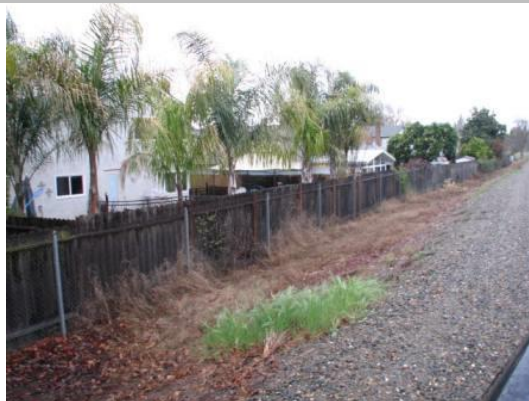
Photo 1 of 1 : SP_2019_NA0001_55_166_20190307_00145.jpg

LM Start	10.75	Rating **	U	Issue No.	166
LM End	10.75	Issue Type +	En	Location *	LS
Category	Earthen Levee			GPS Latitude/Longitude	
				Start	End
Item	Encroachments			38.566705 °	38.566705 °
				-121.352063 °	-121.352063 °
DWR ID	DWR_NA0001_04_s _ 2012_166				
Comment Code					
FE : Fence					
Inspector Comment					
Wooden privacy fence within 10-ft of levee toe.

03/16/2012 Wood privacy fence completely obstructs access and visibility.

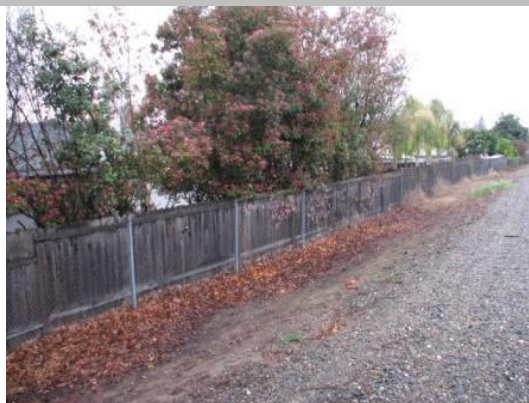
Photo 1 of 1 : SP_2019_NA0001_55_171_20190307_00150.jpg

LM Start	10.76	Rating **	U	Issue No.	171
LM End	10.76	Issue Type +	En	Location *	LS
Category	Earthen Levee			GPS Latitude/Longitude	
				Start	End
Item	Encroachments			38.566499 °	38.566499 °
				-121.351952 °	-121.351952 °
DWR ID	DWR_NA0001_04_s _ 2012_171				
Comment Code					
FE : Fence					
Inspector Comment					
Wooden privacy fence and tall hedge within 10-ft of levee toe.

03/16/2012 Wood privacy fence completely obstructs access and visibility.

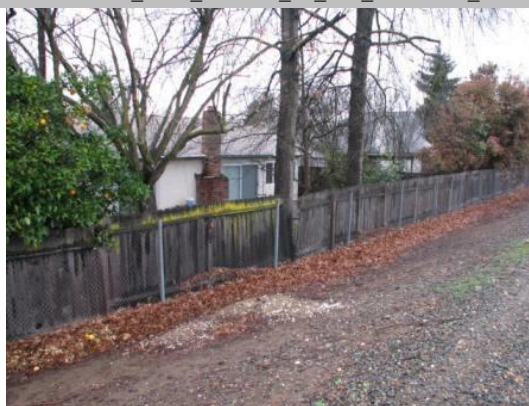
Photo 1 of 1 : SP_2019_NA0001_55_169_20190307_00148.jpg

LM Start	10.77	Rating **	U	Issue No.	169
LM End	10.77	Issue Type +	En	Location *	LS
Category	Earthen Levee			GPS Latitude/Longitude	
				Start	End
Item	Encroachments			38.566399 °	38.566399 °
				-121.351931 °	-121.351931 °
DWR ID	DWR_NA0001_04_s_2012_169				
Comment Code					
FE : Fence					
Inspector Comment					
Wooden privacy fence within 10-ft of levee toe.

03/16/2012 Wood privacy fence completely obstructs access and visibility.

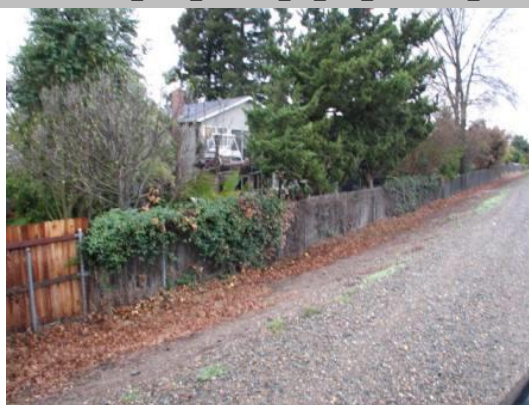
Photo 1 of 1 : SP_2019_NA0001_55_167_20190307_00146.jpg

LM Start	10.78	Rating **	U	Issue No.	167
LM End	10.78	Issue Type +	En	Location *	LS
Category	Earthen Levee			GPS Latitude/Longitude	
				Start	End
Item	Vegetation			38.566233 °	38.566233 °
				-121.351848 °	-121.351848 °
DWR ID	DWR_NA0001_04_s_2012_167				
Comment Code					
V6 : Landscaping					
Inspector Comment					
Planted ivy and vines along with a wooden privacy fence are within 10-ft of the levee toe.

03/16/2012 Wood privacy fence completely obstructs access and visibility.
